Report Identification: 123 Apple St. Anywhere TX

PROPERTY INSPECTION REPORT

Concerning: 123 Apple St, Anywhere, TX
(Address or Other Identification of Inspected Property)

By: Michael Hill # 9175 04/25/2009
(Name and License Number of Inspector) (Date)

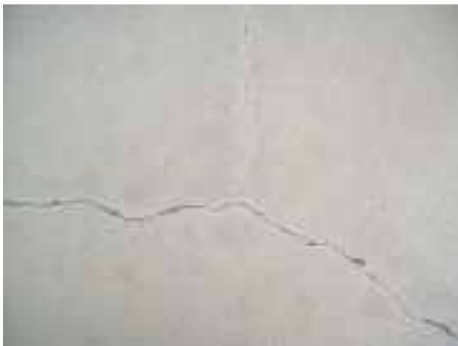
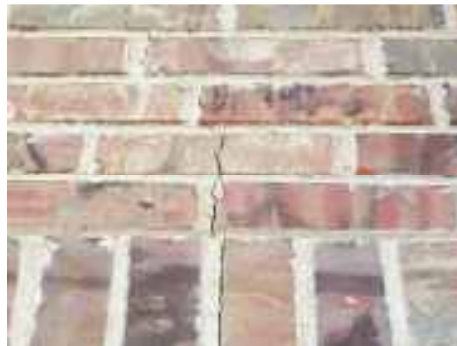
Reportable Differential Movement of Abutting Walkways, Driveways and or Patios were observed. This implies that some reportable movement of the ground has occurred, as is typical of most houses.

Reportable Common Exterior Wall Cracks were observed. This implies that some structural movement of the building has occurred, as is typical of most houses.

Comments: If there are any concerns, I recommend having a Certified & Licensed Structural and / or Foundational Specialist inspect the Foundations and to determine a corrective course of action and proper maintenance.

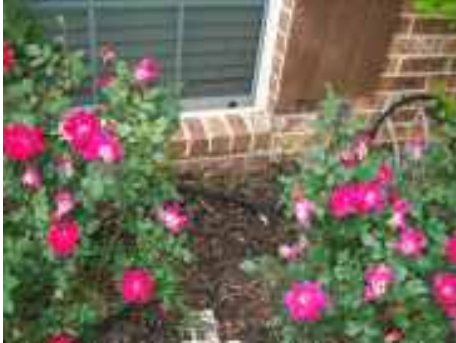
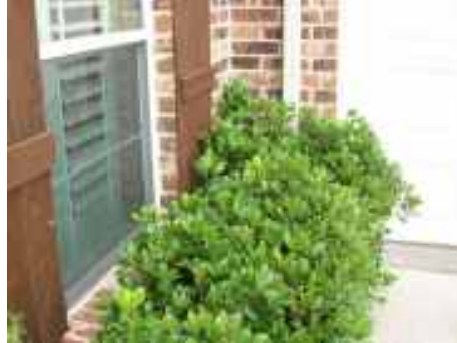
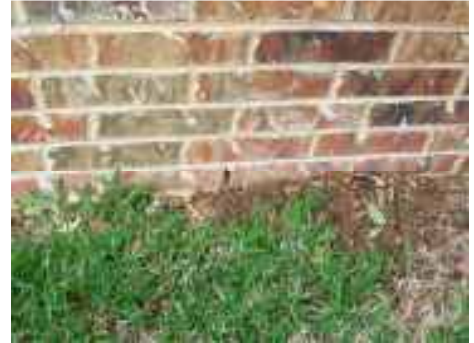
Deficient High Soil Levels against the exterior grade beam were observed in various locations. When soil levels are high against the face of the foundation it promotes water penetration of the structure and is a conducive condition for wood destroying insects (i.e. Termites). This deficiency should be corrected so there is some exposure of the foundation face without creating a negative slope toward the house. It is generally accepted that a brick veneer house should have about 6 inches of clearance

Deficient Heavy Foliage was observed in various locations and is a conducive condition for wood destroying insects (i.e. Termites & Carpenter ants). Foliage should be trimmed at least one (1) foot away from structure to reduce the possibility of insect invasion.

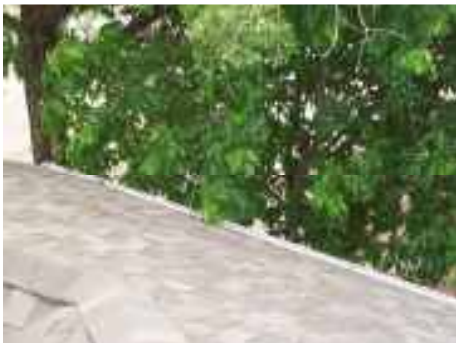
Deficient Trees are Impinging the roof on the front left side of house. Tree branches can damage a roof even in a gentle breeze. Recommend trimming the tree or branches back aggressively, whenever a tree is in contact with or in close proximity of the roof structure.

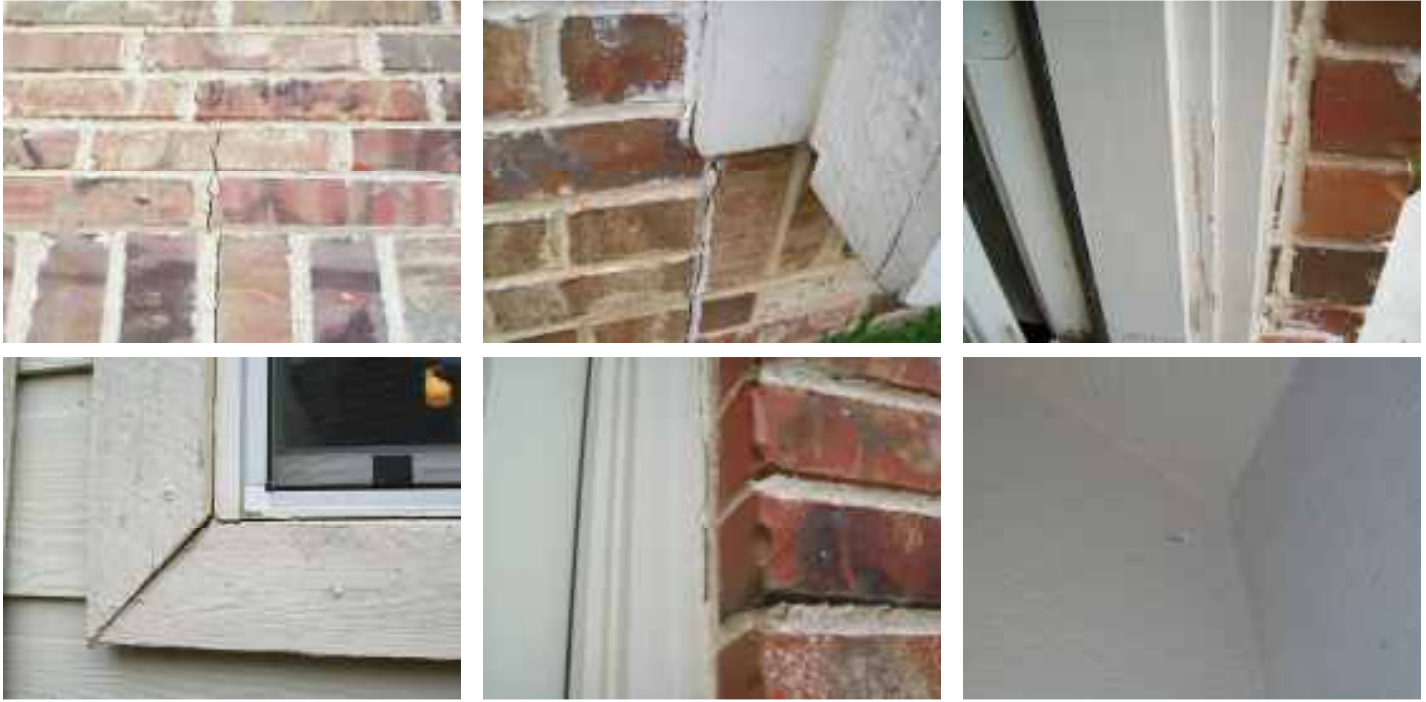
Deficient Exterior Paint / Stain were observed to be Peeling or is showing signs of Wear. Any Exterior Paint / Stain Deficiencies should be corrected in order to protect the durability and structural integrity of external building materials.

Deficient Exterior Caulking was observed. Repair or/ Replaced deficient exterior caulk as necessary.

Deficient Openings and/or Voids in Exterior Building Materials were observed. This is a potential entry point for water and or insects. Openings and/or Voids in exterior building materials should be corrected and sealed as necessary.

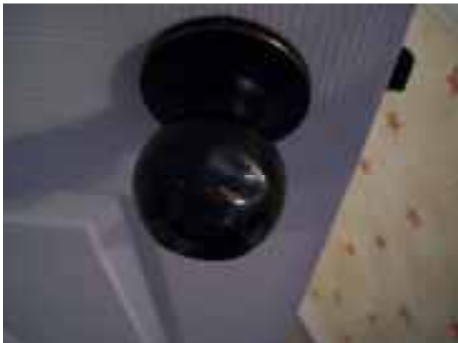
Reportable various door handles were observed to have dents in them. This defect does not effect the performance of the handles and is cosmetic in nature.

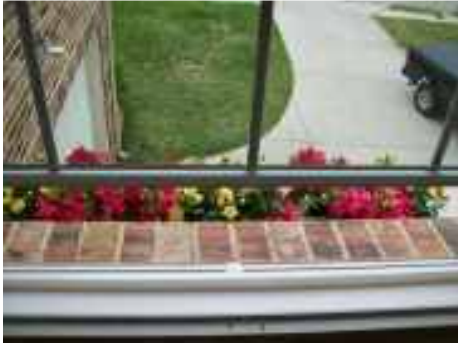
Deficient Missing Window Screens were noted in upstairs bedroom. Screens are mentioned in this part of the report as they are a specific item in the T.R.E.C. guidelines. Screens that are torn enough to allow insect infestation should be repaired. All windows and sliding glass doors that have channels for screens should have them installed. The owner should be consulted regarding any screens that may be in storage.

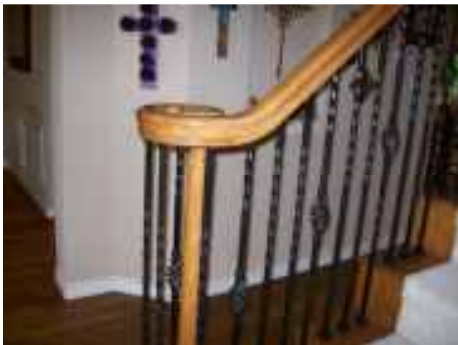
Reportable Loose spindles rattle as one walks up or down stairs. Spindles are usually glued to prevent this rattle.

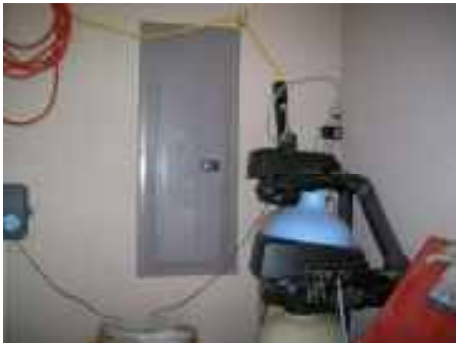
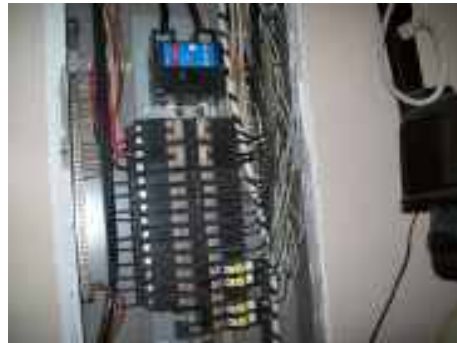
Deficient Lack of Arc Fault Circuit Interrupting Devices was observed. Current TREC Standards require the inspector report as Deficient the lack of arc-fault circuit interrupting devices serving family rooms, dining rooms, living rooms parlors, libraries, dens, bedrooms, sunrooms recreations rooms closets, hallways, or similar room or areas.

Deficient Water softening system was installed to close to main panel. Current building requirements require 36" clearance in front and 30" clearance on side of panel. Because this is water this is considered a Safety Hazard. Move water softening device to another location away from main panel

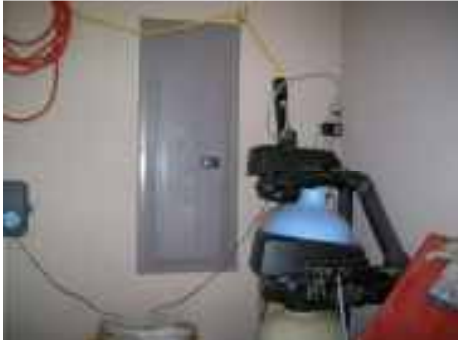
Deficient Extension Cords in the garage should not be used as Permanent Wiring. Remove Extension Cords and connect devices to a permanent outlet or move device to a new location. If a permanent outlet is not present then it will be necessary to add one.

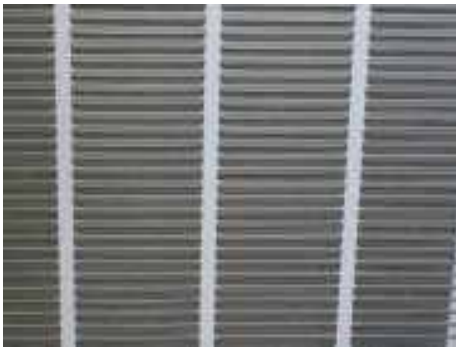
Deficient Filters are dirty. Proper filtering of the air is important. A defective filtering system can lead to dirty evaporative coils and allergy problems. It is a good idea to change or clean these filters every month or as suggested by the manufacturer.

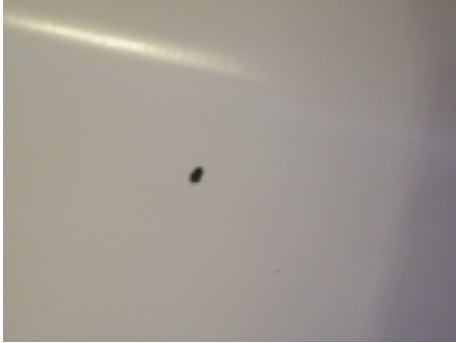
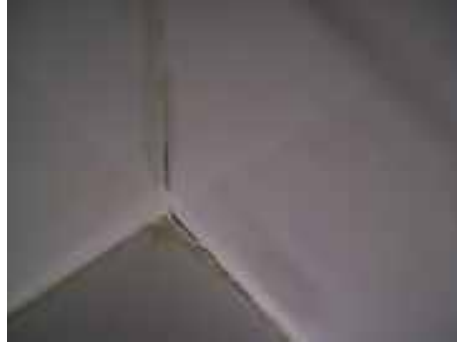
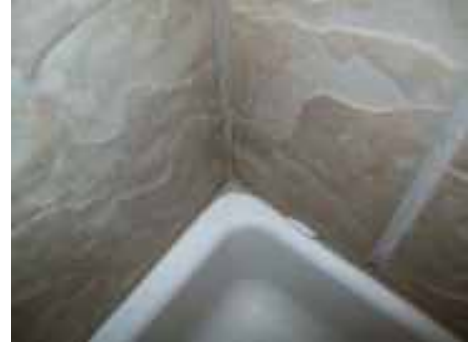
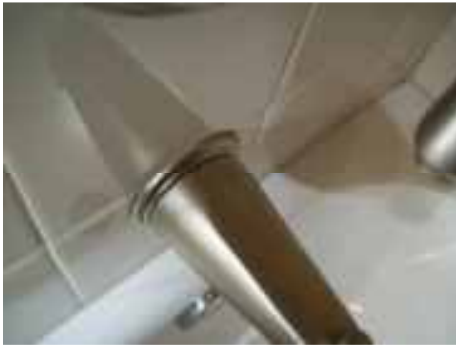
Deficient Damaged Tub Finish was observed in upstairs bath. This condition should be repaired to prevent damage to the structure of the tub by means of corrosion. Repair or replace as necessary.

Deficient Cracked, Deteriorated and/or Missing Bathtub and/or Shower Enclosure Grout and/or Caulk was observed in two baths. Repair or Replace as necessary.

Deficient Seal Around Tub Spouts to prevent water from getting behind them.

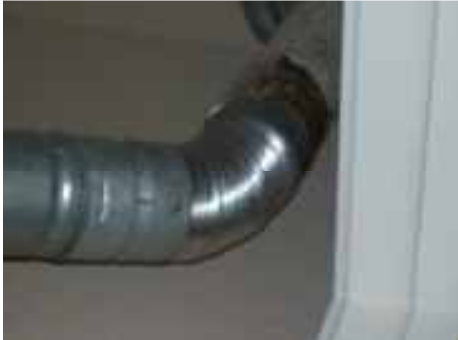
Deficient Flue pipe on water heater does not meet T.R.E.C. guidelines. The flue pipe should be a double walled vent which is sometimes stamped type "b". Replace as required.

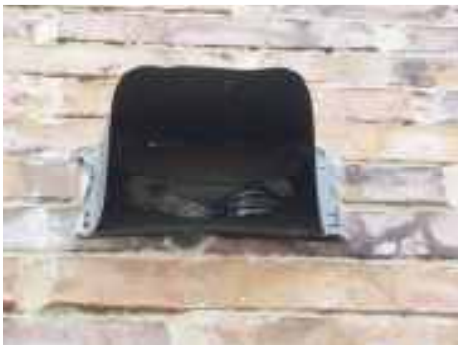
Deficient Vent Door was observed Not to Fully Close while unit is off. This condition could allow insects or birds to enter vent. Repair or Replace as necessary
